Data Recovery from RAID 10 / Dell PowerEdge R430

Data Recovery Case

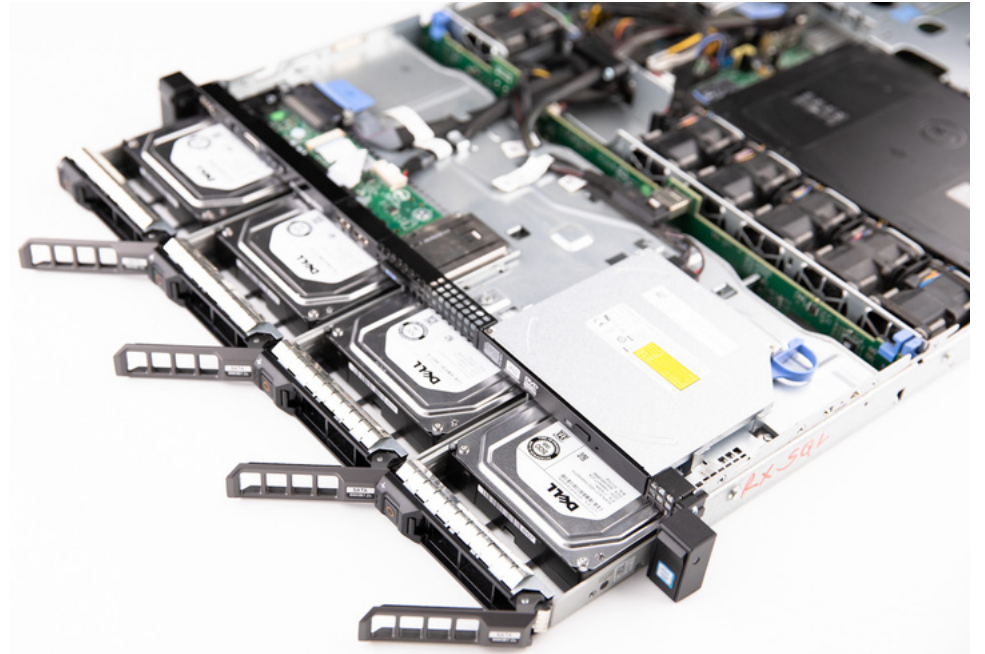
Head Assembly Replacement

One critical aspect of the recovery process was the head assembly replacement performed in a certified cleanroom. This procedure allowed the remaining data to be retrieved.
