# Challenging Data Recovery of Apple Time Capsule 2TB

### Data Recovery Case

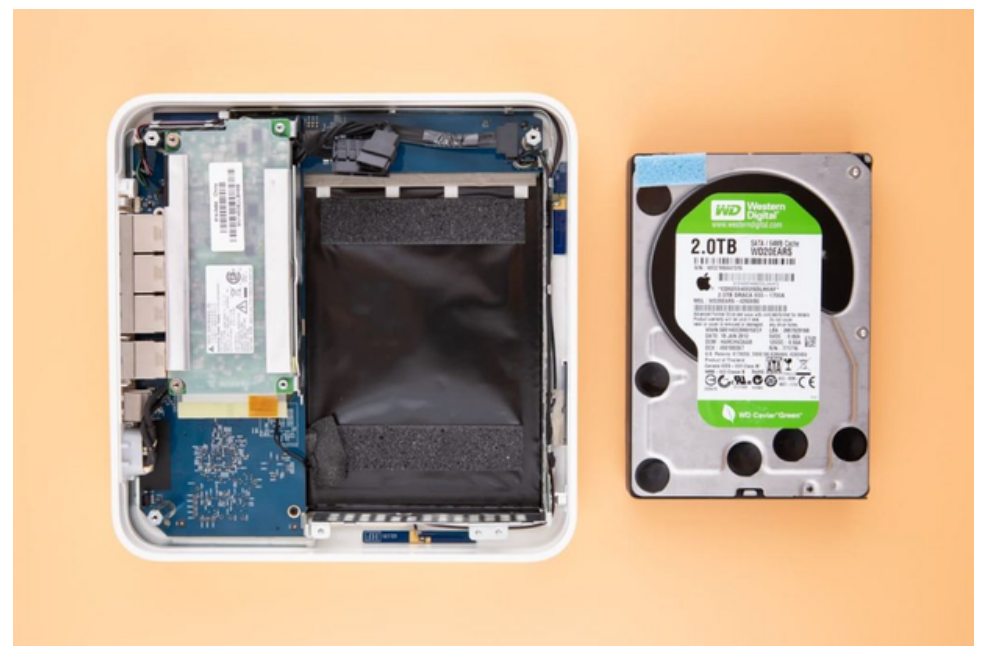
Sparsebundle, an outdated disk image format, was employed by the Apple Time Capsule. We developed proprietary software to translate this format into a readable filesystem, allowing us to retrieve the correct folder and file names.

Using our advanced methods, we mounted the Sparsebundle disk image files and successfully recovered all files, including lost photos and videos. The restored data was saved to a new external SSD drive and promptly shipped to the client.
