# Data Recovery of RAID 5 Array on HP ProLiant ML380 G6 Server

### Data Recovery Case

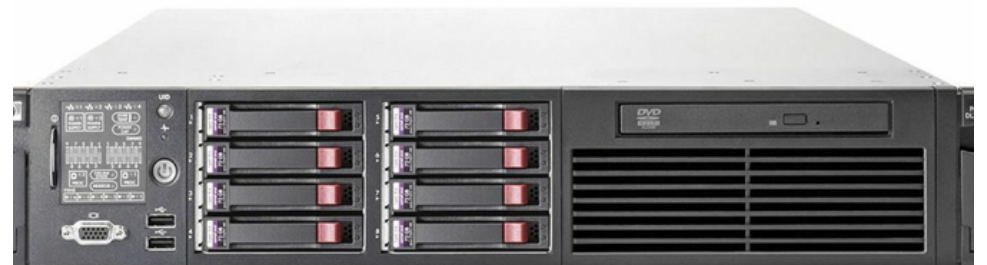
With cloned copies of each RAID member, we focused on analyzing the RAID configuration. Entropy analysis with the correct block size and drive count confirmed that the drives were part of a RAID 5 volume with 128-sector block size and 16-block delays. As the RAID controller did not support RAID 6, our attention remained on RAID 5 recovery.

Using the advanced RAID recovery software, we reconstructed the logical volume with precise RAID parameters. It is crucial to consider only working RAID member drives with up-to-date data to avoid potential file damage. Once the logical volume was established, we successfully copied all customer data from the D partition to a USB external hard drive.
